# **FORD TECHNICAL** **BULLETIN**

## **Problem with Ford Mondeo and** **Transit Starter Motor TDCi 2000>>**

**Subject: Starter motor Failure**

**Model: Ford 2.0 TDCi FWD & 2.4 TDCi RWD/2.0 TDCi FWD**  
**FORD MONDEO 2.0 TDCi &**  
**FORD TRANSIT STARTER: AES2202**

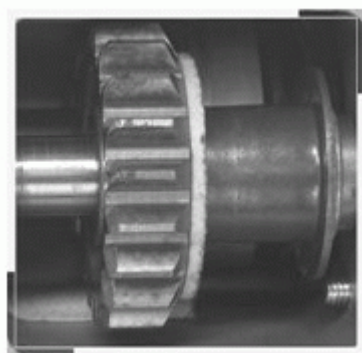
The unit is failing due to significantly high levels of metal dust particles contaminating the pinion housing.

On inspection, the units do not exhibit any manufacturing defects. The premature failure of the unit is due to contamination of the pinion/drive area from metal dust particles produced within the Dual-mass Flywheel, when the clutch wears or becomes overheated. During scheduled servicing, it is recommended that the clutch is checked and if found to be showing signs of wear should be replaced.

Replacing a starter unit that is found to be contaminated with high levels of metal dust particles in the pinion area and the transmission bell housing has not been thoroughly cleaned out before installing the replacement unit, will lead to the unit failing in a short period of time.
